Procedia CIRP 11 (2013) 291 – 295

[www.elsevier.com/locate/procedia](http://www.elsevier.com/locate/procedia)2<sup>nd</sup> International Through-life Engineering Services Conference

# Real-time Monitoring of Wind Turbine Generator Shaft Alignment using Laser Measurement

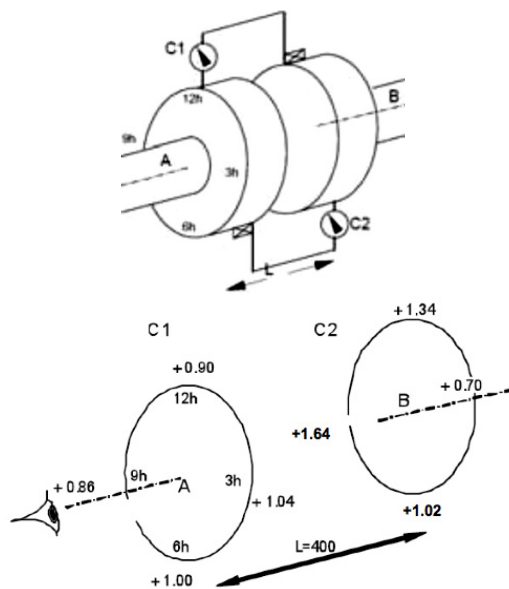
Fig. 1. Shaft alignment procedure

The 'C1' and 'C2' locations are measurements located at an angular difference of  $180^\circ$ . The longer the distance of 'L' is the better, as it increases the sensitivity of angular error detection. The readings should be performed at least 4 times for the 'C1' and 'C2' measurement locations: that being at the 12h, 3h, 6h, 9h clock-wise locations. The results from these measurements can then be evaluated as in Figure 2. The values given are an example in millimetres, where the reading is considered positive (+) when the measurement is towards the shaft. In assessing the measurements referring to the vertical plane, the deflections are shown below as an example:

Though small degrees of misalignment do not cause transmission losses, it is still a serious concern. Lin et al detected the motor shaft alignment using multiscale entropy with wavelet denoising [5]. Lees investigated the misalignment in rigidly coupled rotors [6], Pennacchi et al modelled the nonlinear effects caused by coupling misalignment in rotors [7]. However these tests tend to be one-off tests and are not conducted based upon shaft misalignment and additionally there is no regular monitoring. In order to perform regulator monitor, measurements need to be taken as in Figure 1, from Vesta [8], below:

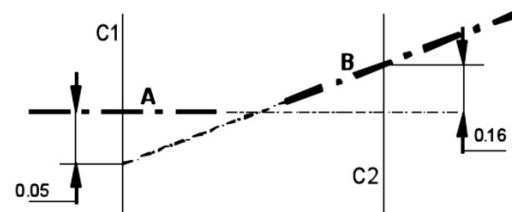
Considering the vertical plane of 'C1', the vertical action towards the top of shaft 'A' on the measurement device is dominant. In the plane 'C1' the axis 'A' is higher than axis 'B' (at 0.05mm average deflection at  $180^\circ$  opposed measurements). In the vertical plane measurement 'C2', as shown in Figure 2, shows that the vertical action towards the top of shaft 'B' measured is greater. In the plane 'C2' the axis 'B' is higher than axis 'A' at 0.16mm. Therefore in the vertical plane the angular alignment error can be evaluated as 0.0525 mm.

Fig. 2. Eccentricity calculation geometry – vertical axis

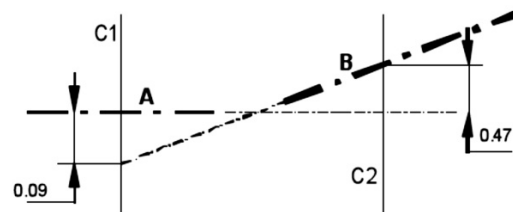
In this plane, 'C1', the axis 'B' is further downwards than 'A' at 0.09mm of deflection. In the plane 'C2' the axis 'B' is further upwards than 'A' at 0.47mm of deflection (again, average deflection at  $180^\circ$  opposed measurements). As such the horizontal angular error can be evaluated as 0.14mm.

Fig. 3. Eccentricity calculation geometry – horizontal axis

Measurements can therefore also be taken referring to the horizontal axis, as shown in Figure 3 below:

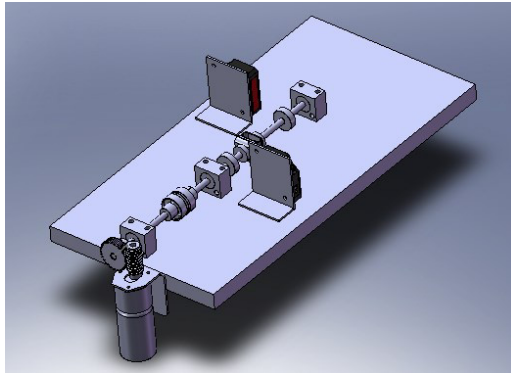
In order to perform real-time shaft alignment, a laboratory test rig has been created that operates at the typical rotational rates of a wind turbine in the order of 120rpm using two lasers. The general assembly, as shown in Figure 4 is a motor that simulates the turbine rotating, connected via a straight shaft to two flanged couplings and a flexible coupling. Two measurement devices evaluate the distance to pulleys

mounted on both sides of the motor shaft flanged and also flexible coupling (to separate tests). These lasers determine the variation in radii of the shaft as it rotates. A photosensitive sensor is used as a rotary encoder to determine when the shaft has completed a rotation, and via an electronic comparator, gives a TTL trigger signal. Additionally the alignment calculation, as shown in Figure 2 and Figure 3, to determine horizontal and vertical alignment can be computed 'on the fly' and hence the measurement of misalignment can be readily evaluated. The test was conducted on both the flanged coupling used to test radial misalignment and the flexible coupling used to test axial angular misalignment.

Fig. 4. Shaft alignment test rig CAD model

In this test, the physical structural deformation of the shaft is not experimented as the lasers would equally measure alignment error whether it was caused by poorly connected couplings or shaft deformation, either way each result would show a delta movement in shaft distance.

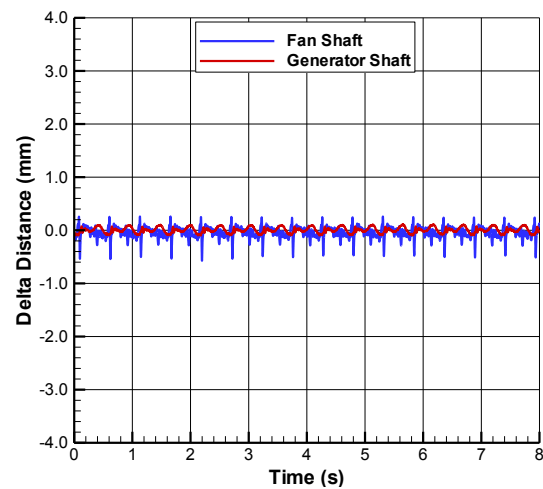
Results for this test configuration can be seen in Figure 5 showing the results for multiple shaft rotations, and then Figure 6, showing the results ensemble-averaged for the periods shown in Figure 5. The results are interpreted by looking at differences in the average between the two sides of

the coupling (which shows shaft misalignment) and then variation in amplitude as the shaft rotates (which represents eccentricity of the coupling alignment). So, ideally, the shafts will have the same average and little amplitude variation during rotation. It can be seen that when the flanges are correctly aligned, the variation in distance of the coupling wall varies only nominally though a minor variation of a few decimals of a millimetre can be seen. Equally the downstream coupling, representing the fan shaft, also has a nominal coupling wall distance variation. The results of the time history were then time averaged, in Figure 6, which shows very good correlation between the two laser distance measurements. Note the peak seen, especially in the fan shaft trace, which presents the cut-away in the flanged coupling, evident in the images of the flanged coupling presented earlier. No correction is made in any of the results presented for the 180° phase shift between the motors, as the proposed method uses periodic peak-to-peak measurements and as such no alignment of instantaneous measurement result is required.

Fig. 5. Flanged coupling, laterally aligned, time history data

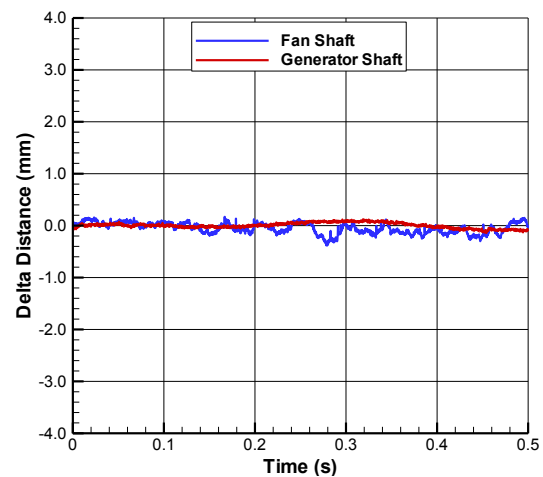
Fig. 6. Flanged coupling, laterally aligned, ensemble averaged data

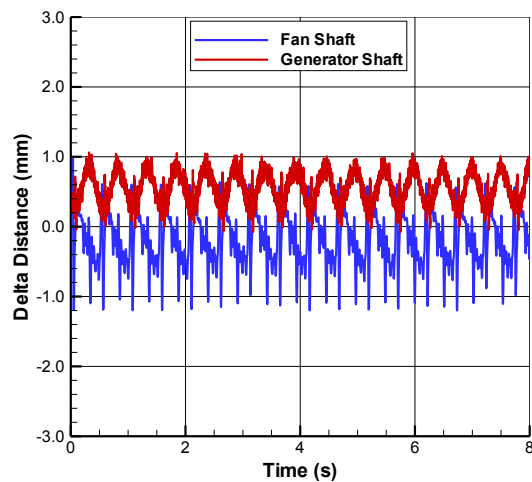
The tests were now repeated with the flanged coupling misaligned, with the time history and ensemble averaged data shown in Figure 7 and Figure 8 respectively. It can now clearly be seen that there is both a DC shift between the fan and generator shaft reading and also periodic amplitude due to the misalignment. The ensemble averaged results also show the clear variation in coupling sidewall distance with rotation, with a clean signal seen for the generator shaft and a more noisy (mainly due to the rapid variation in distance relative to laser response time) trace evident for the fan shaft.

Fig. 7. Flanged coupling, laterally misaligned, time history data

The peak-to-peak variation for the fan shaft was found to be  $\pm 0.49$ mm, with an average of  $+0.51$ mm, and the peak-to-peak variation for the generator shaft found to be  $\pm 0.38$ mm, with an average of  $\pm 0.32$ mm. With  $C_1$  as  $1.00$  and  $0.02$ mm and  $C_2$  as  $0.70$  and  $-0.06$ mm, the vertical alignment of drive shafts for lateral misalignment is  $0.085$ mm and horizontal

alignment of drive shafts for lateral misalignment is  $-0.002$ mm.

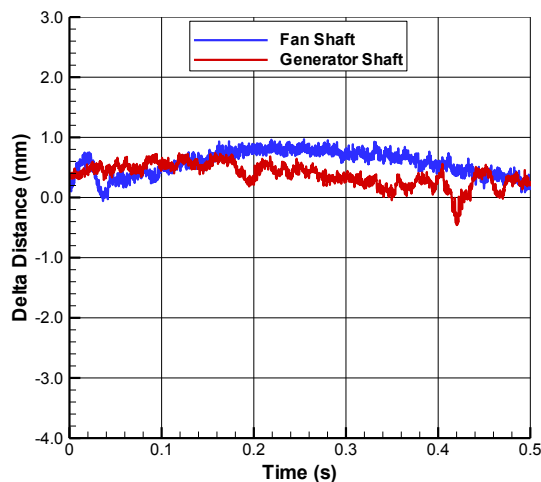
Fig. 8. Flanged coupling, laterally aligned, ensemble averaged data

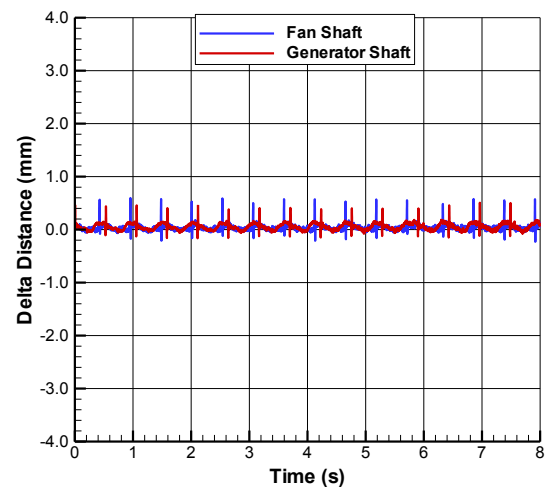
The lasers were then remounted, with the distance measurement targeted on the flexible flange sidewalls, with the results reported in Figure 9 and Figure 10 for the time history and ensemble-averaged data, respectively. It can be seen that there is a nominal sidewall distance variation with shaft rotation on both the fan and generator shaft sides of the coupling, with the spike in the time history data representing the cut-away in the coupling for the fixing grub screw (visible in images of the flexible coupling earlier). The ensemble-averaged data, in Figure 10, also clearly shows neither no DC shift nor periodic variation in the sidewall distance.

Fig. 9. Flexible coupling, axially aligned, time history data

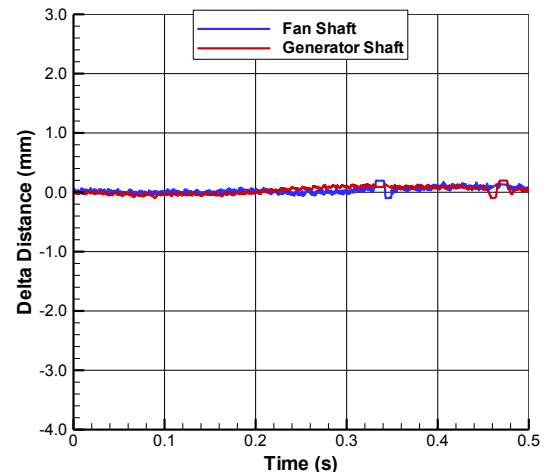
Fig. 10. Flexible coupling, axially aligned, ensemble average data

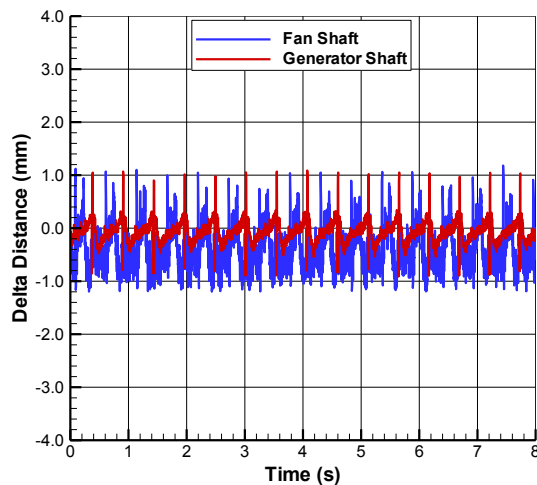
Figure 11 and Figure 12, show the results for the time history and ensemble averaged data, respectively. It can be seen that, though step change exists between the sidewall measurements either side of the coupling, the couplings are clearly out of alignment due to the periodic amplitude. The ensemble-averaged results show much less noisy results relative to the time history, suggesting that the ensemble averaging offers a far clearer result. It can also be seen in the ensemble averaged result prominent peaks where the cut-away for the grub screw is located, and the distinct peak at this location confirms accurate shaft angle triggering (otherwise the peak would be smoothed). The results show that the generator shaft has an average result of -0.12mm and an amplitude of 0.24mm, versus an average of -0.08mm and an amplitude of 0.76mm for the fan shaft measurement. It is expected that the fan shaft deflects more greatly than the generator shaft due to the test rig applying the misalignment on the fan shaft side.

Fig.11. Flexible coupling, axially misaligned, time history data

The peak-to-peak variation for the fan shaft was found to be  $\pm 0.56$ mm, with an average of -0.18mm, and the peak-to-peak variation for the generator shaft found to be  $\pm 0.28$ mm, with an average of -0.04mm. With  $C_1$  as 0.38 and 0.74mm and  $C_2$  as 0.24 and -0.32mm, the vertical alignment of drive shaft for axial misalignment is 0.031mm and the horizontal alignment of drive shafts for axial misalignment is 0.021mm.

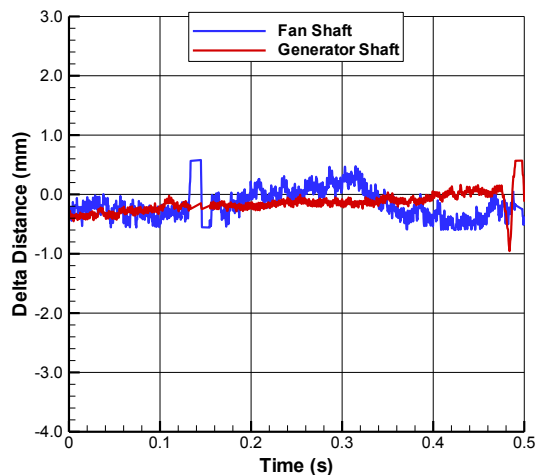
Fig.12. Flexible coupling, axially misaligned, ensemble average data
